Photographs for Mid City Plating Company CEI 6/22/2010

Media: RCRA

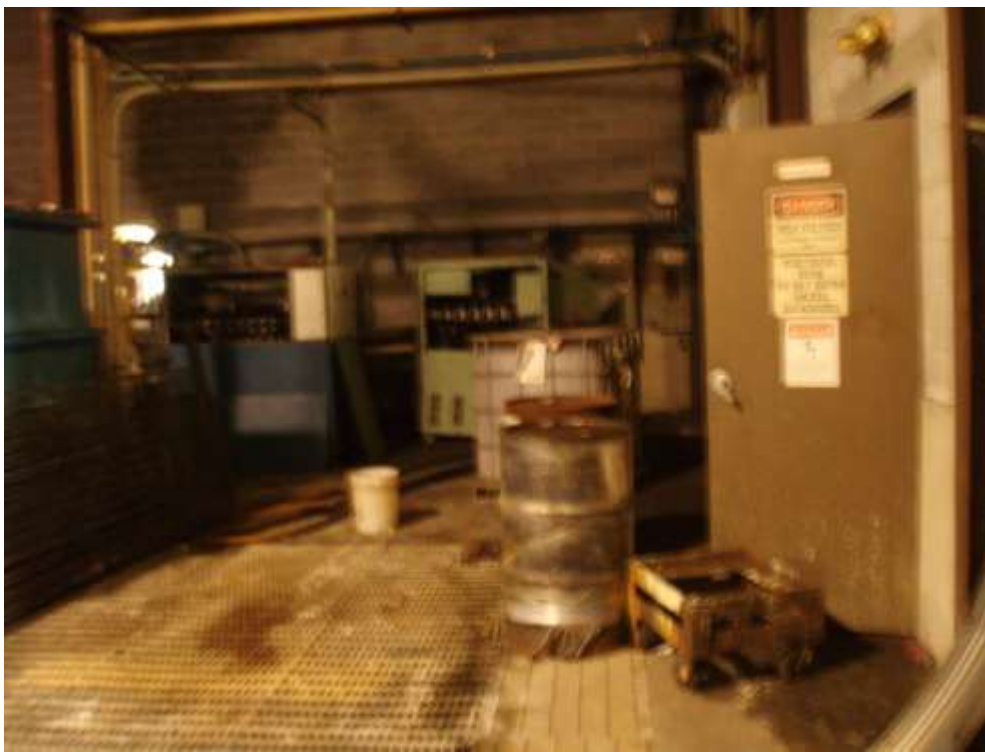
Trench with a grate, located in maintenance room, on West side of facility, was located within the floor. Liquid was being stored within the pit. Cleaner collects inside of grate and is pumped to WWT unit.

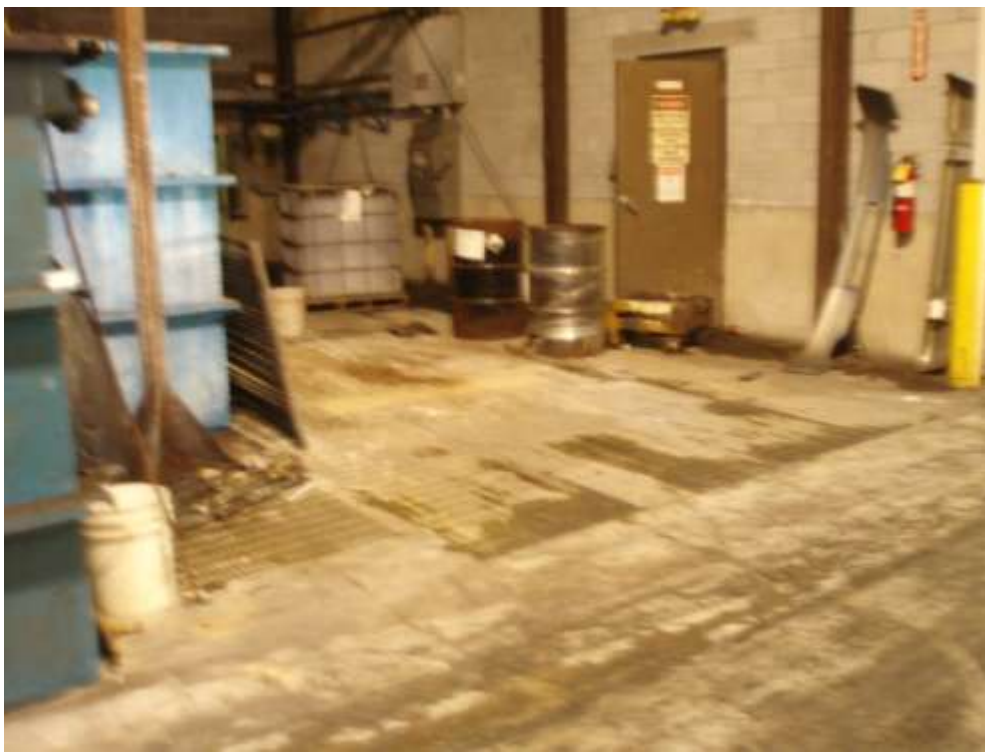
Trench with a grate, located in maintenance room, on West side of facility, was located within the floor. Liquid was being stored within the pit. Cleaner collects inside of grate and is pumped to WWT unit.
